(12) TROPICAL TESTING ESTABLISHMENT  
PORT HARGOURT, NIGERIA

## THE BEHAVIOUR OF PAINTS IN THE TROPICS

November, 1961

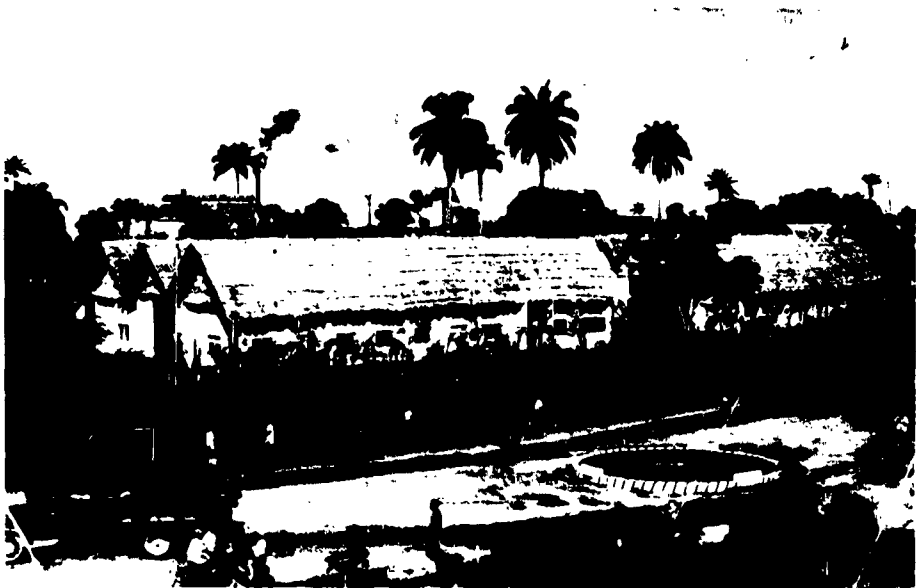
Fig.2 General view of town site, Port Harcourt. Specimens were placed in an open compound behind building at right centre of the photograph (see Fig.3). The base depot store (Fig.4) was part of the large building in centre of photograph.

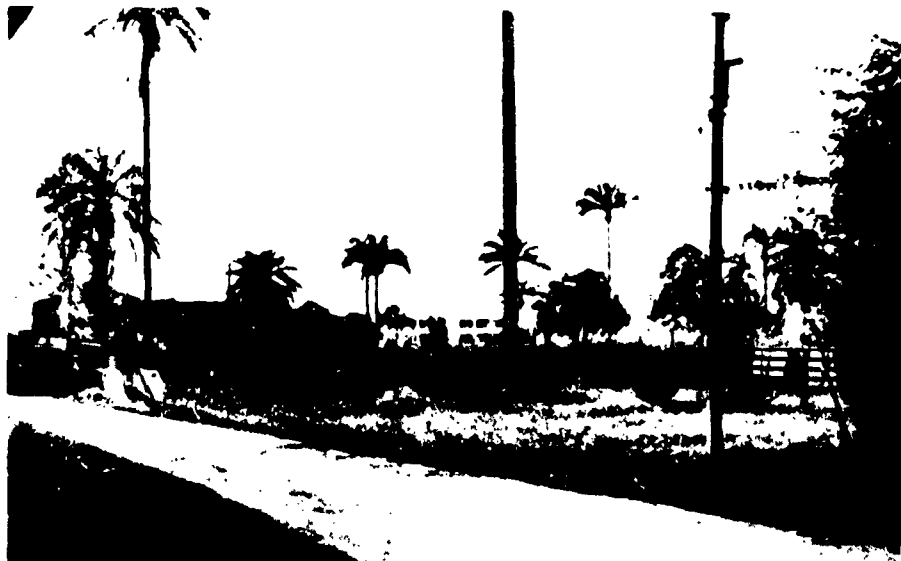
Fig.3 General view of exposure compound at town site, Port Harcourt.

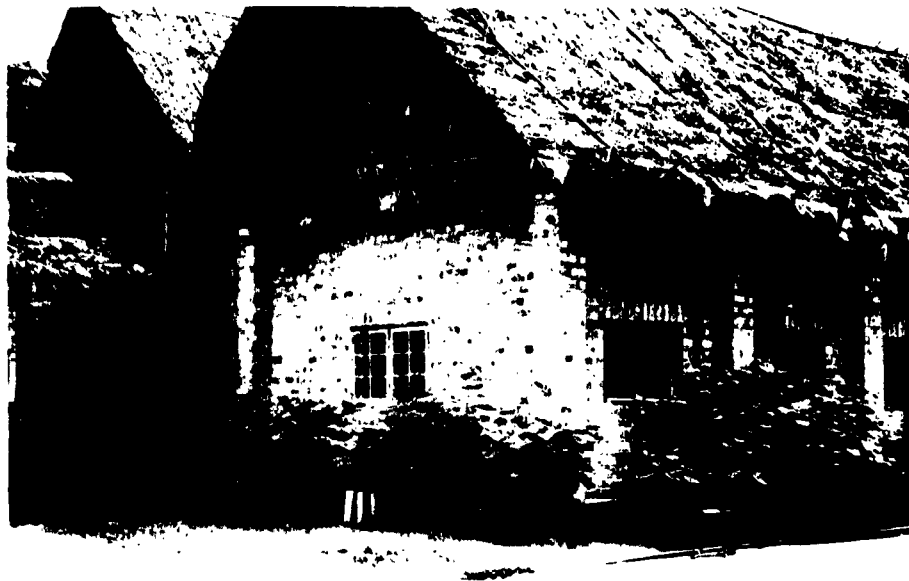
Fig.4 Exterior of base depot store, Port Harcourt.

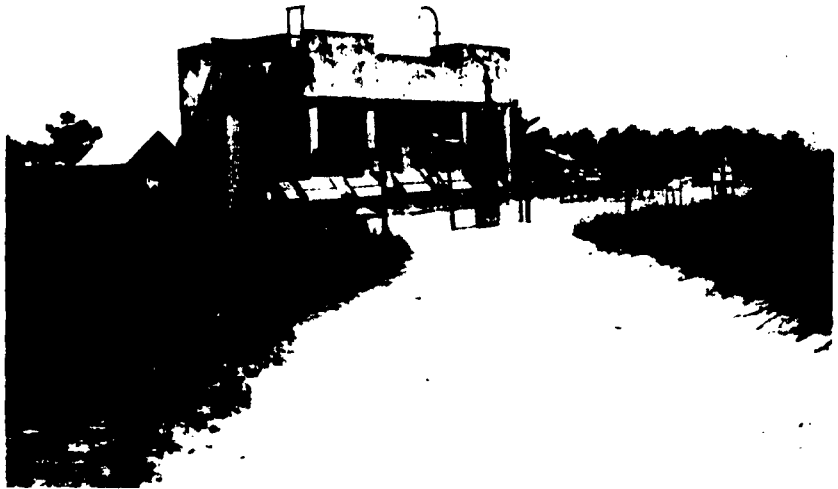
Fig.8 General view of exposure compound 200 yards from surf line at Lighthouse Beach, Lagos (Marine Site - 200 yd).

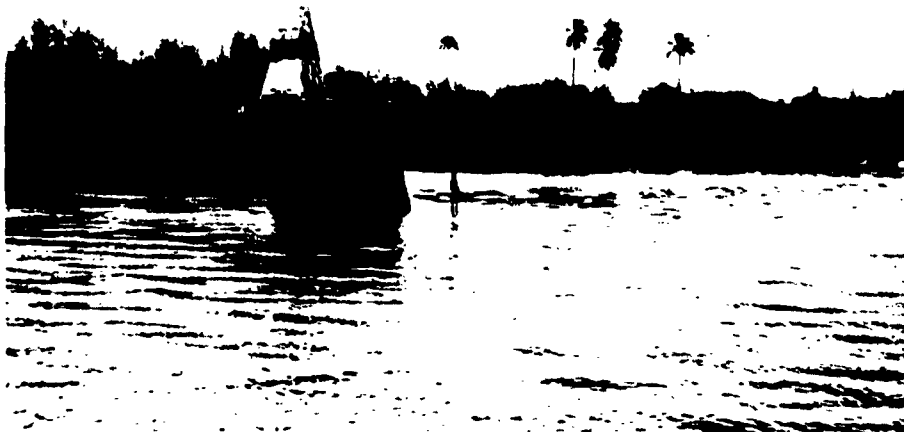
Fig.10 General view of the dolphin in the Bonny River,  
Port Harcourt (Harbour Site).

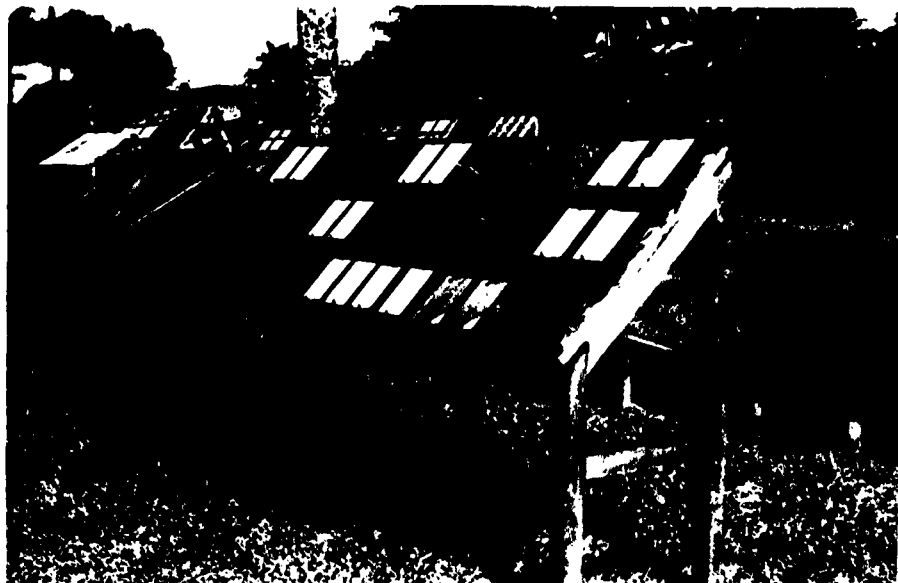
Fig.12 Experimental Paints (W. and S. Leigh Ltd.)  
exposed at the town site, Port Harcourt.

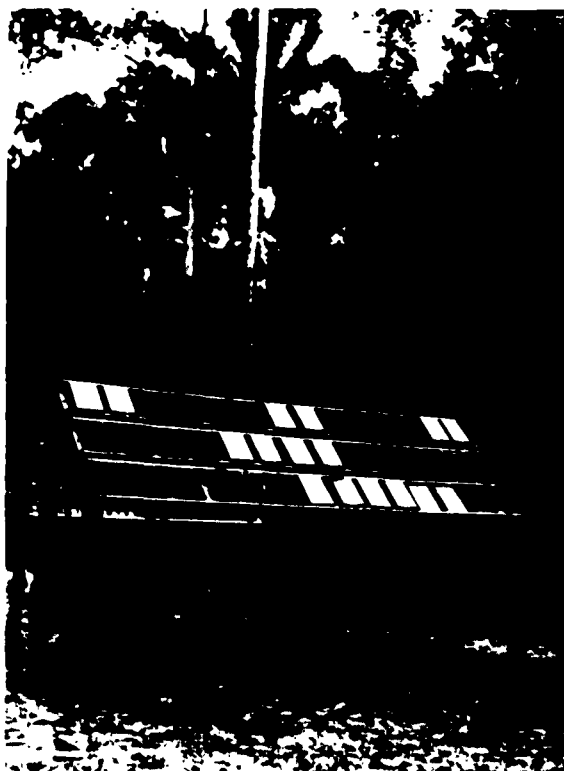
Fig.13 Experimental Paints  
(W. and S. Leigh Ltd.)  
exposed in the jungle  
clearing, Nkpoku.

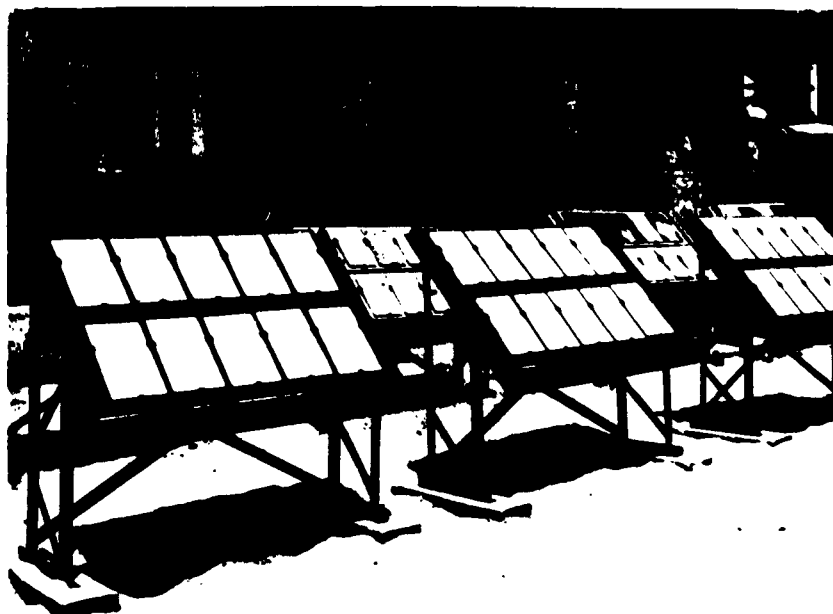
Fig.15 Priming Schemes for Metallic Coatings (Trial  
sponsored by the British Iron and Steel Research  
Association). Panels exposed at the marine site  
(200-yard compound).

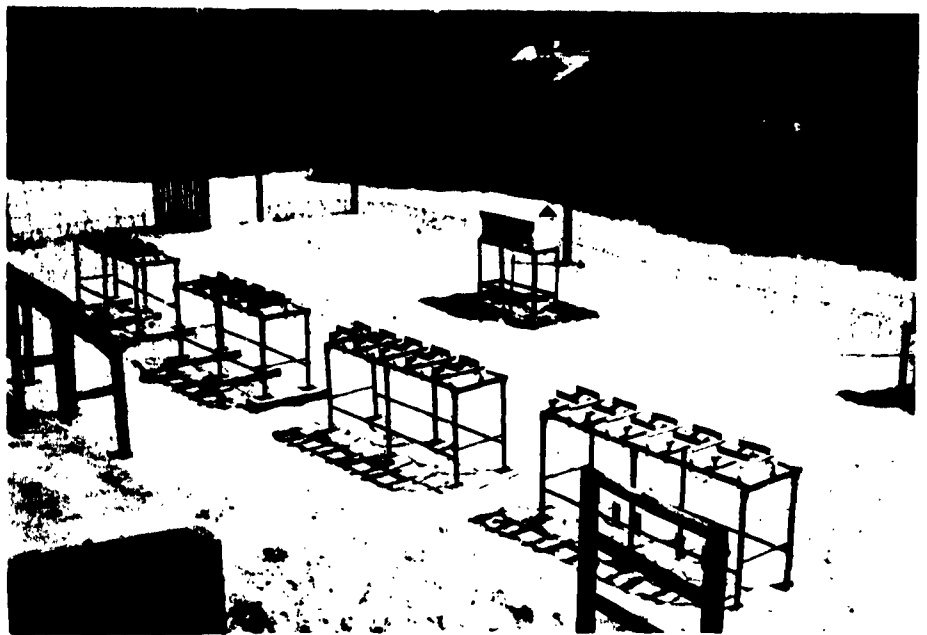
Fig.16 Priming Schemes for Metallic Coatings (Trial sponsored by the British Iron and Steel Research Association). Complex shapes on exposure at the marine site (200 yard compound).

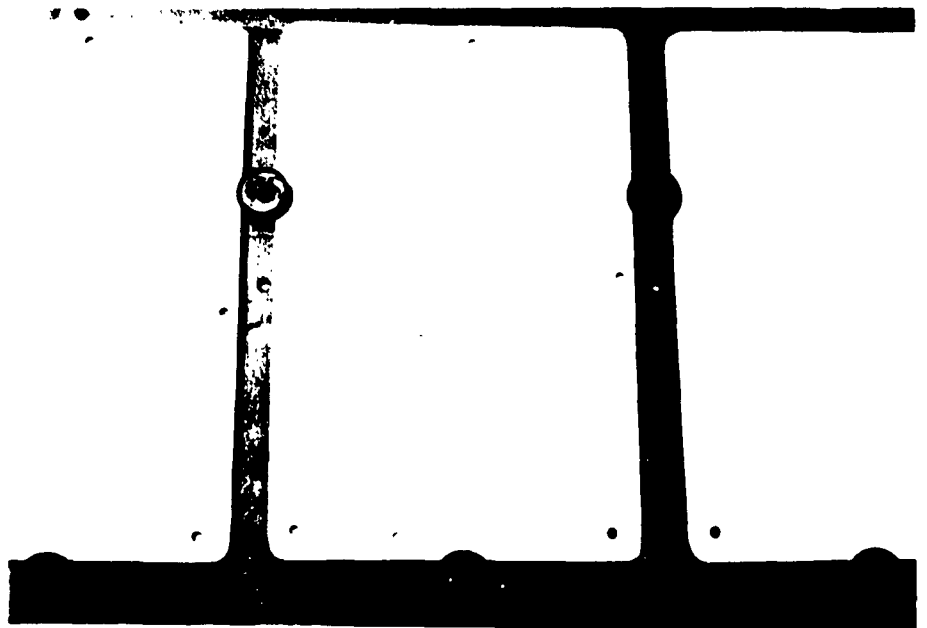
Fig.17 Priming Schemes for Metallic Coatings (Trial sponsored by the British Iron and Steel Research Association). The method of supporting the panels on the exposure stand is shown.

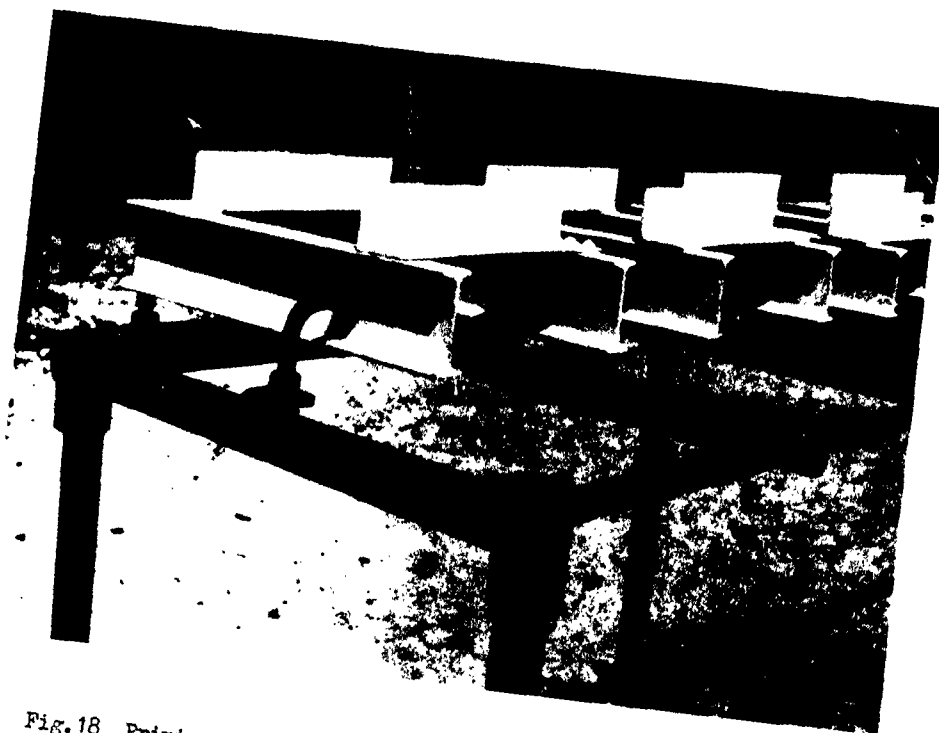
The effect of type of priming paint on the protection of steel was investigated by exposing painted panels and fabricated specimens of complex shape (Fig.18) at the marine site for nineteen months (30). Normally such a trial should last several years but it had to be terminated prematurely because of the closure of T.T.E.

Fig.18 Priming Schemes for Metallic Coatings (Trial sponsored by the British Iron and Steel Research Association). The method of exposing the complex shapes is shown.

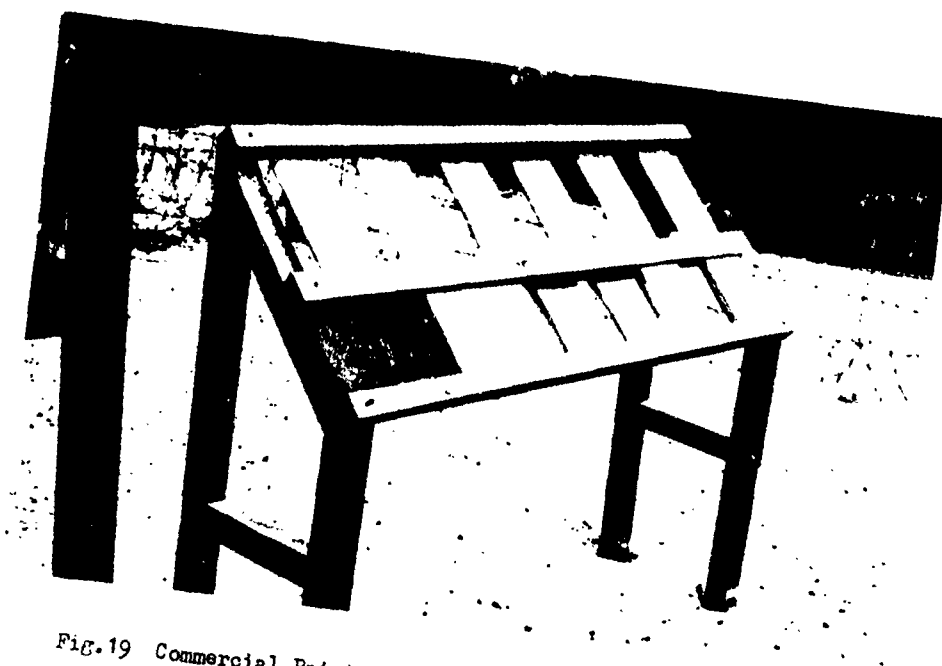
Fig.19 Commercial Paints and Enamels (Jenson & Nicholson Group) exposed at the marine site, Lagos. The steel panels with paints for the protection of structural steel are on the top row and the enamel coated wooden panels on the bottom.

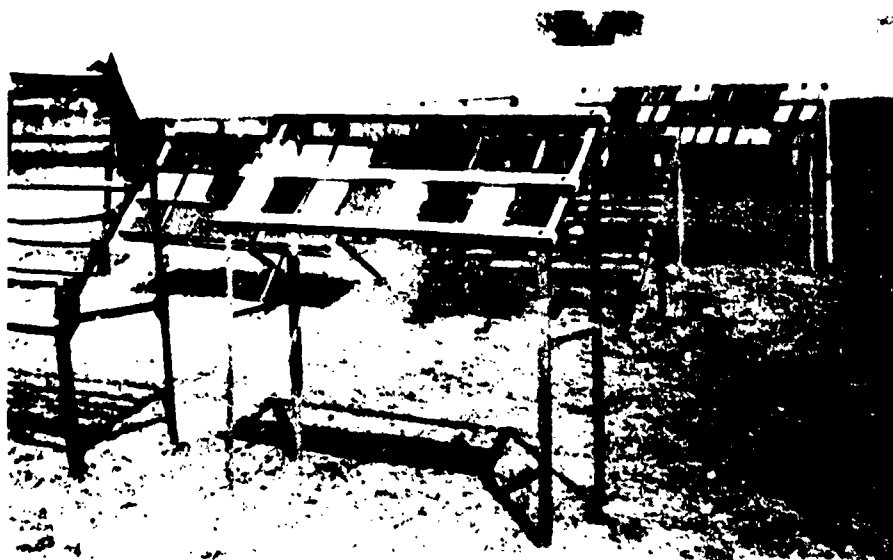
Fig.23 Commercial Enamels (Jenson and Nicholson Group)  
exposed at desert site, Kano.

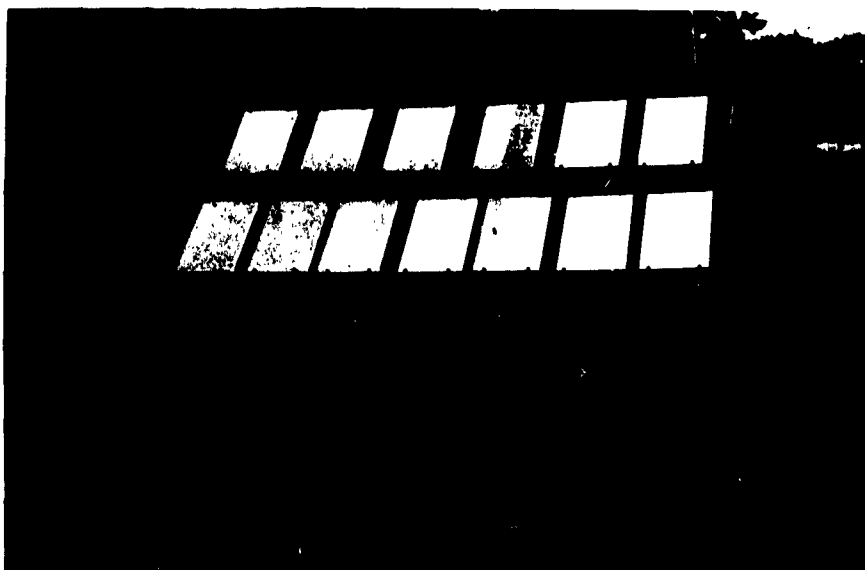
Fig.26 General Purpose Paints (Red Hand Compositions Co.  
- 2nd Trial) exposed at marine site, Lagos.

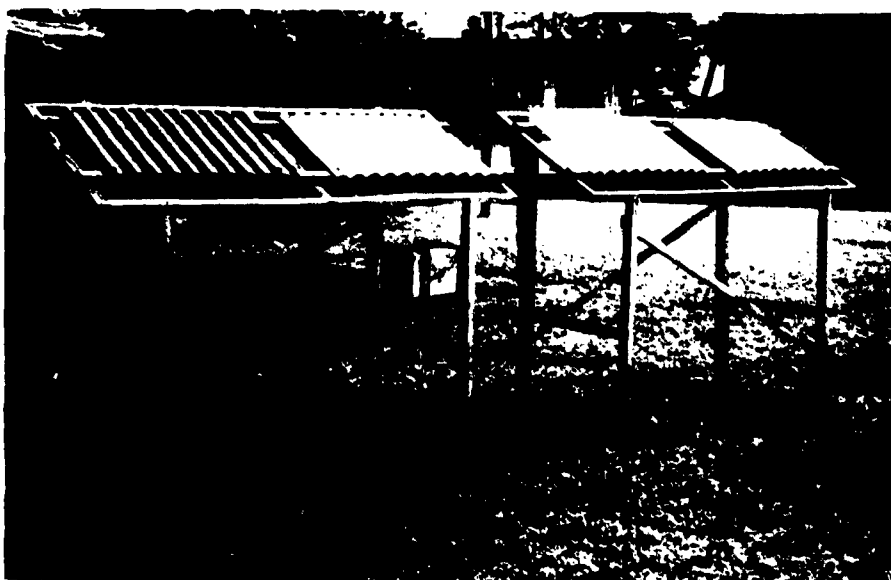
Fig.27 Turnall Colouglaze (Turner Asbestos Cement Co. Ltd.)  
exposed at town site, Port Harcourt.

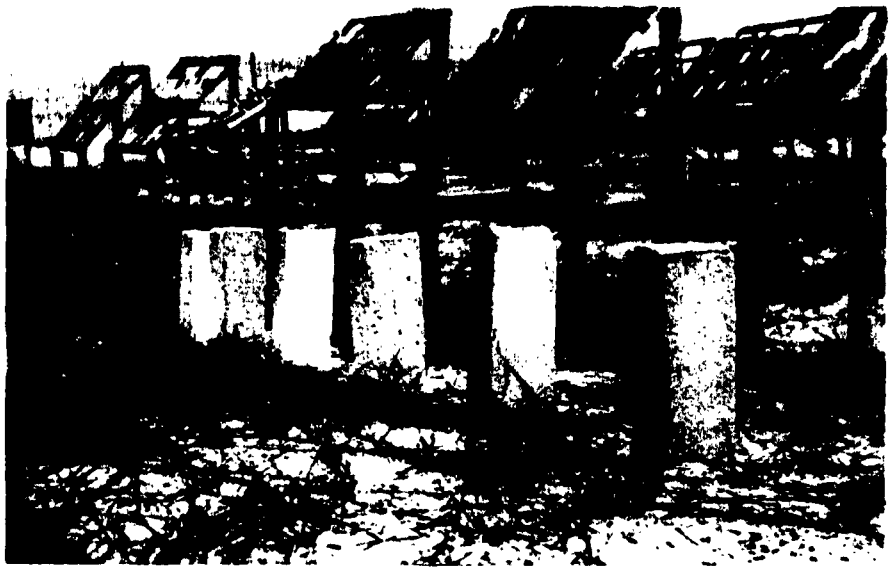
Fig.28 Plastic Emulsion Paints (Jenson & Nicholson Group)  
exposed on concrete blocks at the marine site,  
Lagos (50 yard compound).

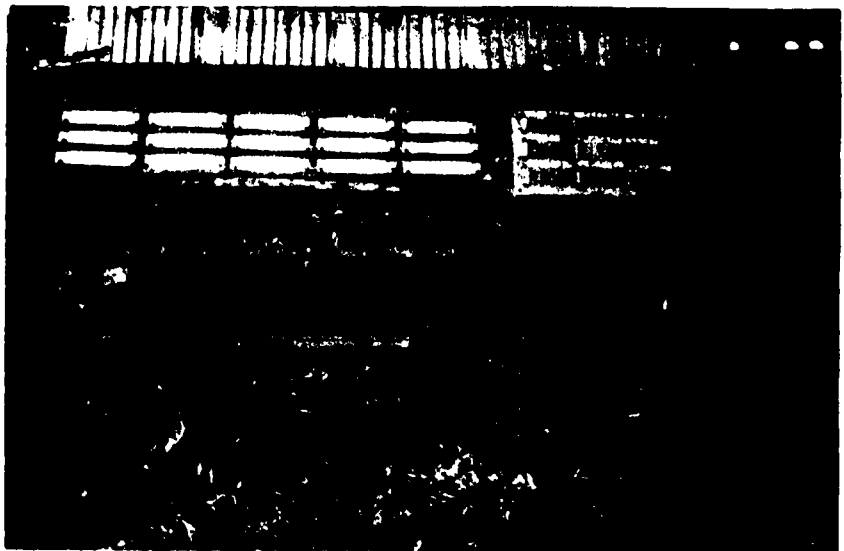
Fig.29 Picture Varnishes (Trial sponsored by the  
National Gallery) exposed at desert site, Kano.

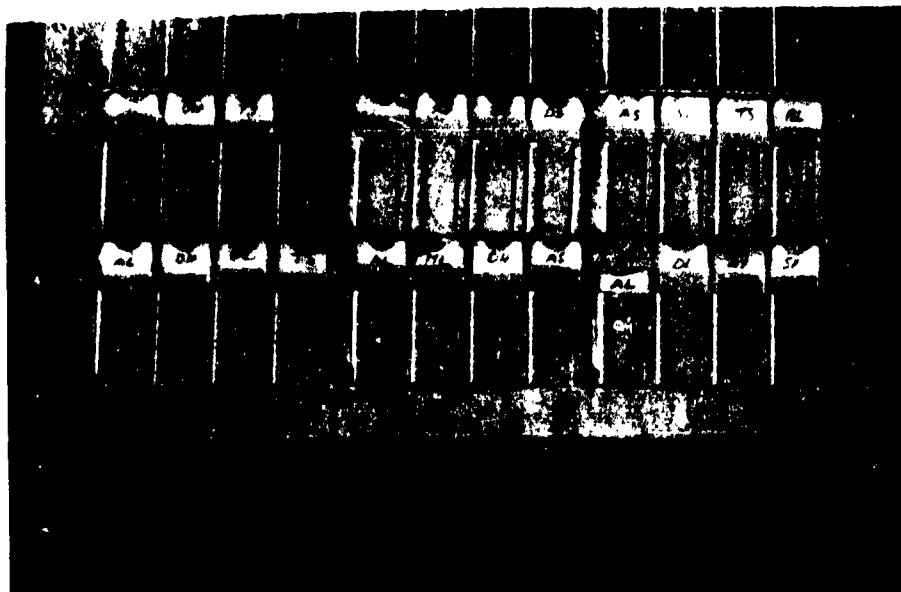
Fig.30 Picture Varnishes (Trial sponsored by the National Gallery). Specimens exposed on clear glass (microscope slides) at desert site, Kano.

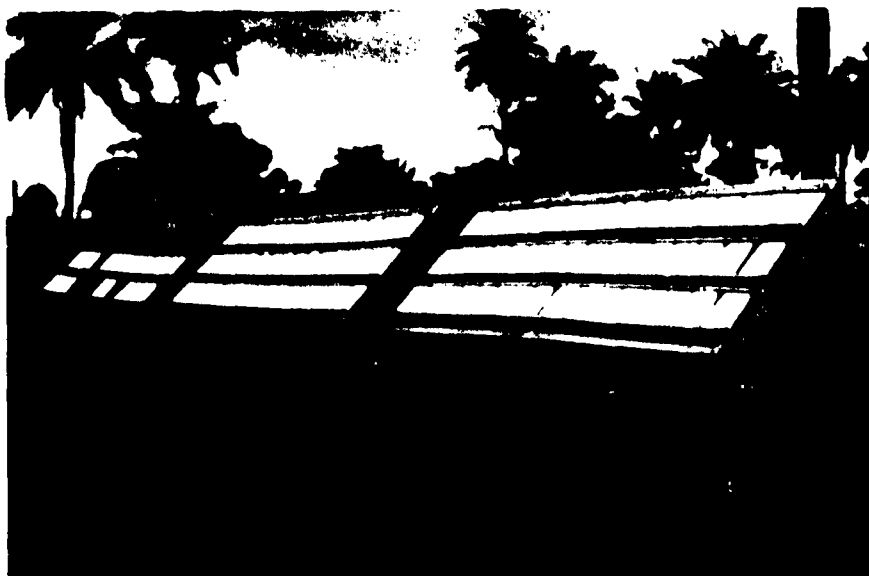
Fig.31 Fungus Resisting Paints (I.C.I. Ltd.) exposed at town site, Port Harcourt.

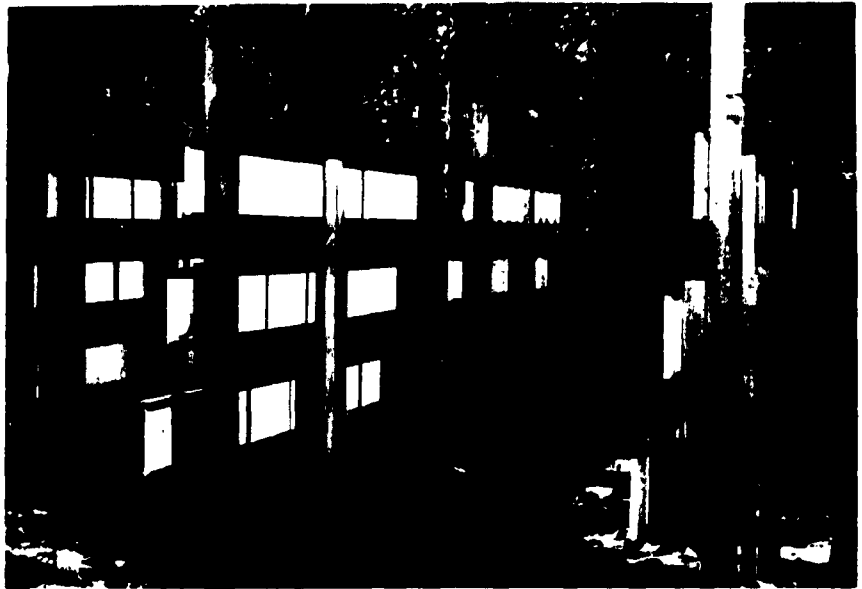
Fig.32 Fungus Resisting Paints (I.C.I. Ltd.) exposed in jungle undergrowth, Nkpoku.

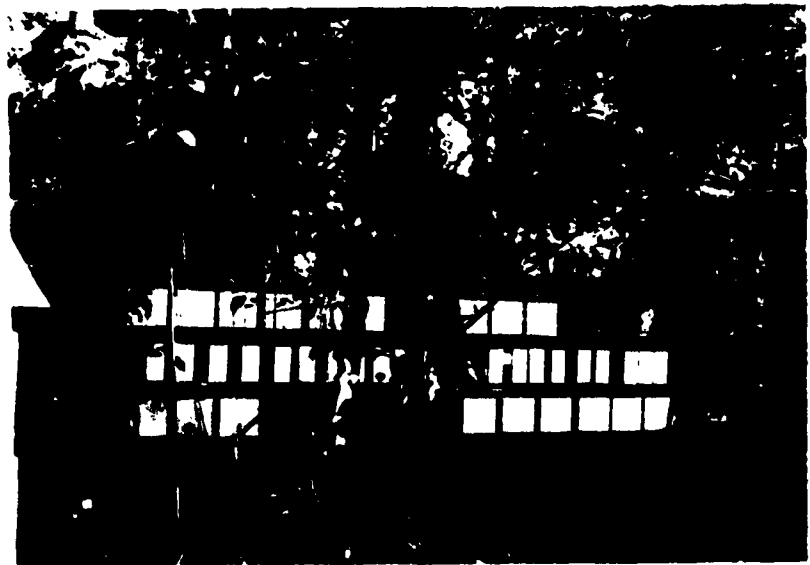
Fig.33 Fungicidal Paints and Varnishes (Trial sponsored by M.O.S., Chemical Inspectorate). Specimens exposed in jungle undergrowth.

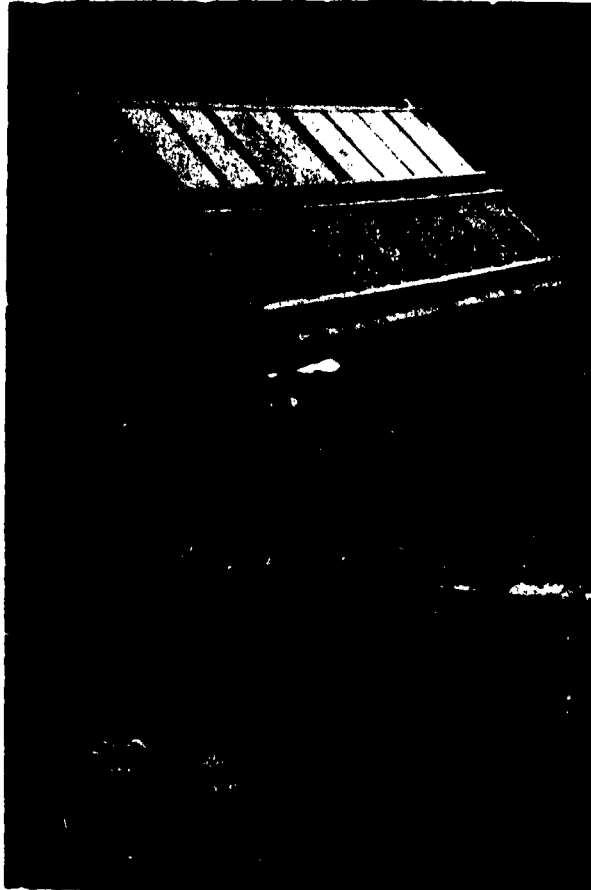
Fig. 34 Fungicidal Paints  
(Goodlass Wall & Co. Ltd.)  
exposed in the jungle  
clearing, Nkpoku.
